ANNUAL REPORT FOR 2008

Wastewater Treatment Mitigation Site
New Hanover County
TIP No. U-92 A/B

Prepared By:
Natural Environment Unit & Roadside Environmental Unit
North Carolina Department of Transportation
September 2008

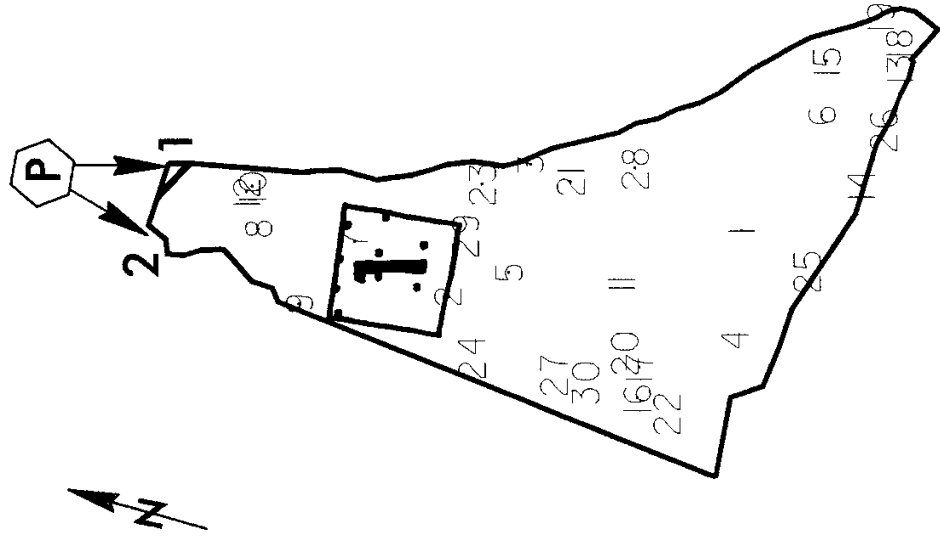
Wastewater Treatment Site

2008 Photo, Plot, and Random Point Locations
